FLOOD PLAIN INFORMATION

RED CLAY CREEK

NEW CASTLE COUNTY DELAWARE

CORPS OF ENGINEERS, U. S. ARMY
PHILADELPHIA DISTRICT
FEBRUARY 1971

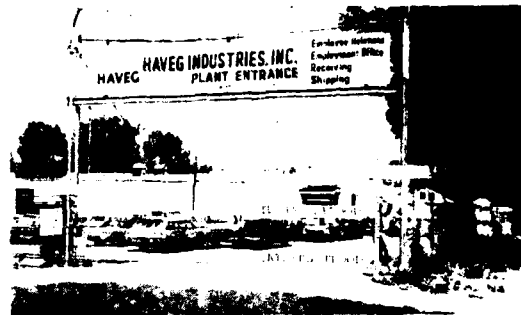
Photograph 1 - Possible future flood heights at the Haveg Industries, Inc., Plant.

The Haveg Industries, Inc., suffered damages to their electrical equipment in Building 24. Many of their electric motors had to be dismantled and baked, while others were rewound. Damages also included a full day's lost time cleaning up and several days' work at 40% production.

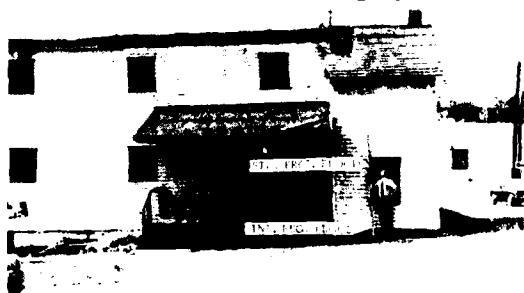
Photograph 2 - Possible future flood heights at historic Greenbank Mill in Cedars.

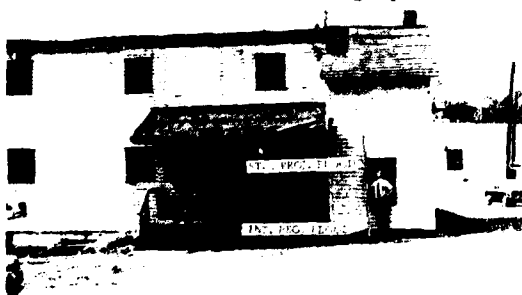
Photograph 2 - Possible future flood heights at historic Greenbank Mill in Cedars.

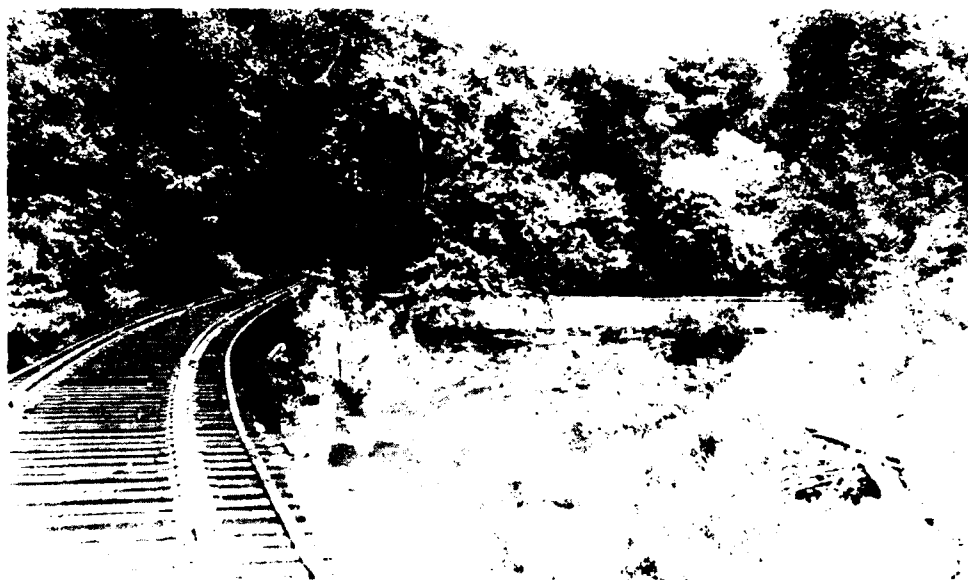
Figure 1.--DAMS ACROSS RED CLAY CREEK

Top view shows the dam downstream from the Yorklyn-Hockessin Road at Mile 11.6. The bottom view shows the concrete dam upstream from the timber trestle Baltimore and Ohio Railroad bridge at Mile 10.9.

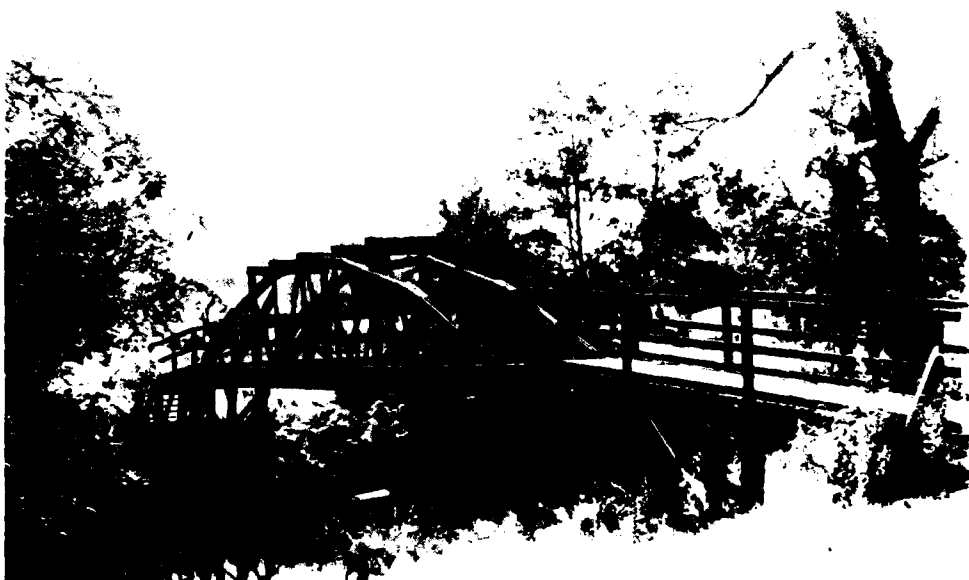
Figure 4.--BRIDGES ACROSS RED CLAY CREEK

Top view shows the downstream view of the Lancaster Pike reinforced concrete bridge. The U.S.G.S. stream gage is located on the upstream side at Mile 5.0. Bottom view shows the wooden foot bridge near the Greenbank Mill at Mile 2.8.

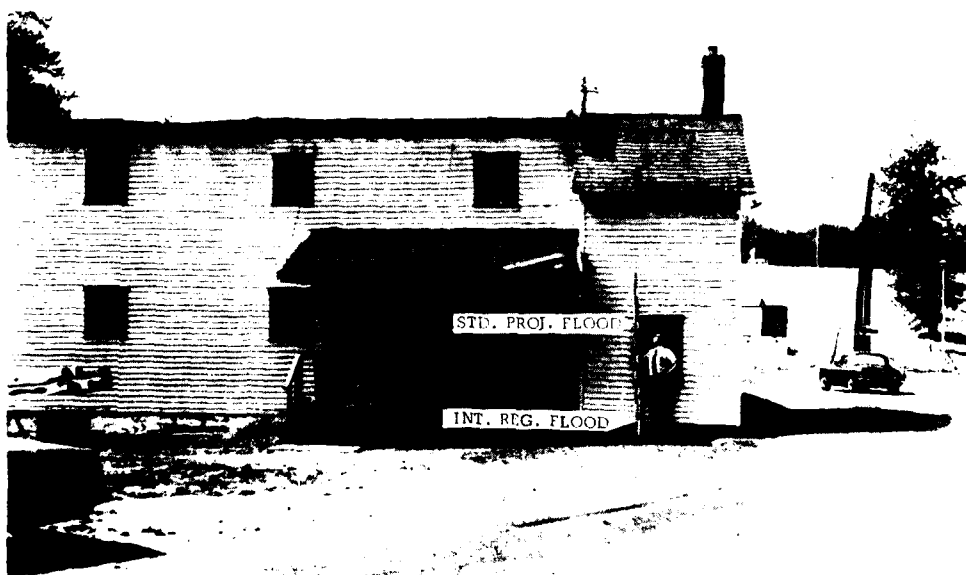
Figure 5.--FLOOD HEIGHTS ALONG RED CLAY CREEK

Top view is the National Vulcanized Fibre Plant at Yorklyn, Mile 11.6. Bottom view shows the historic Greenbank Mill at Mile 2.8. The Standard Project Flood and Intermediate Regional Flood heights that would be reached at these locations are shown by the arrows.

Figures 5 and 6 show the heights that would be reached by the Intermediate Regional and Standard Project Floods at selected locations within the study area.

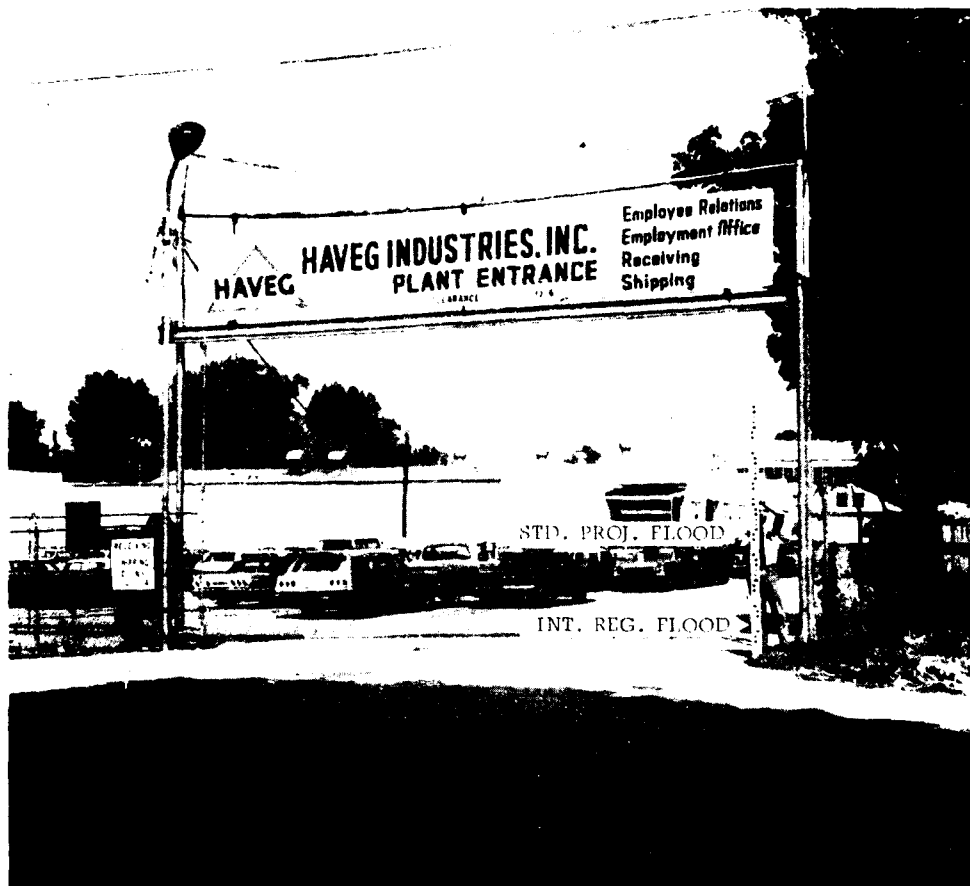
Figure 6.--FLOOD HEIGHTS ALONG RED CLAY CREEK

The arrows in the view above indicate the heights that would be attained by the Intermediate Regional and Standard Project Floods at Mile 1.97 along the Old Capital Trail.
